Test Report

Applicant Beijing Goldrare Automobile Parts Co.,LTD.

Sample Name H6 Driver seat

3.1. 6-Axis vibration test

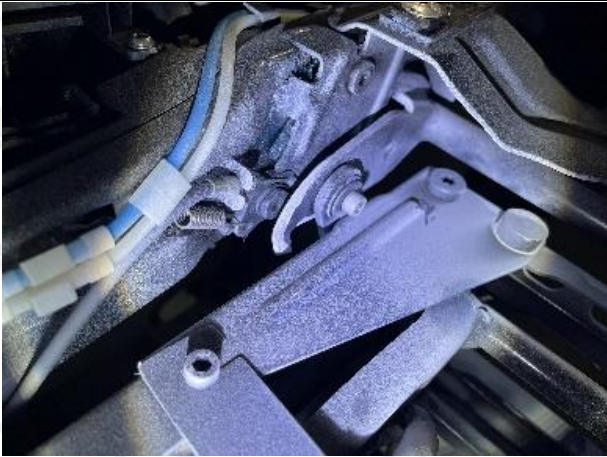
Tilt System	No crack, structure broken, weld off, screw loosen or fall off, or severe deformation detected; The new designed tilt structure showed a good performance during whole test mileage, no teeth slip occurred and the position could be maintained perfectly.
Sliding Rail	No crack, structure broken, weld off, screw loosen or fall off, or severe

After test-Tilt System	After test-Sliding Rail

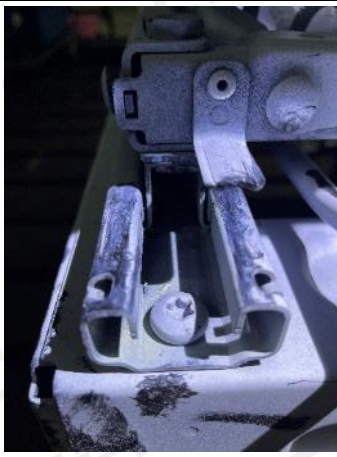
deformation detected; The sliding rail could be locked, unlocked or adjusted smoothly after whole test mileage.
Seat Back Frame	No crack, structure broken, weld off, screw loosen or fall off, or severe deformation detected; Especially no structure failure of curving and welding position detected.
Seat Riser	No crack, structure tearing, severe deformation or weld off detected on seat riser. The screw connection between rail and seat riser maintained well.

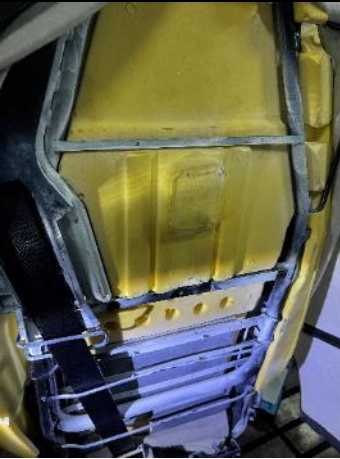
After test-Seat Back Frame	After test-Seat Belt System

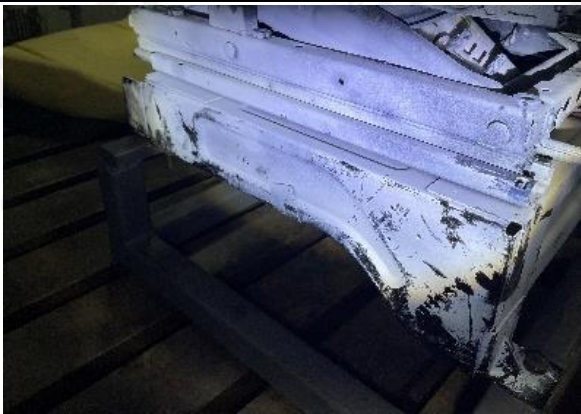
/
After test-Seat Riser	/
