# Test Report

项目名称 Project Name: Daimler H6 Seat

样品名称 Specimen Name: A9609109720 Climate Suspension Seat  
w/o pretensioner or DPD

**Test Report Number: SHTC-MAST-22-04**

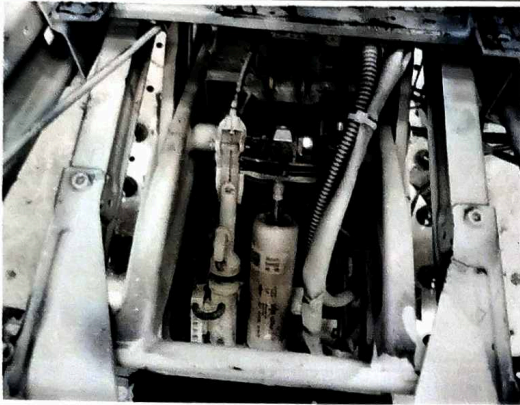
Image 31 Seat Suspension Frame

No crack, structure broken, weld off, screw loosen or fall off, or severe deformation detected;  
No air breakage of valve system or air bag;  
No function failure of suspension use.

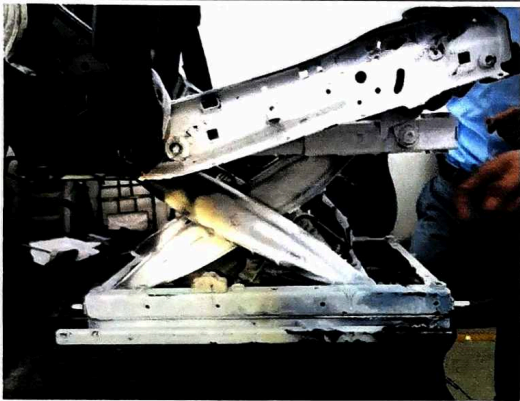
Image 32 Tilt System

No crack, structure broken, weld off, screw loosen or fall off, or severe deformation detected;  
The new designed tilt structure showed a good performance during whole test mileage, no teeth slip occurred, and the position could be maintained perfectly.

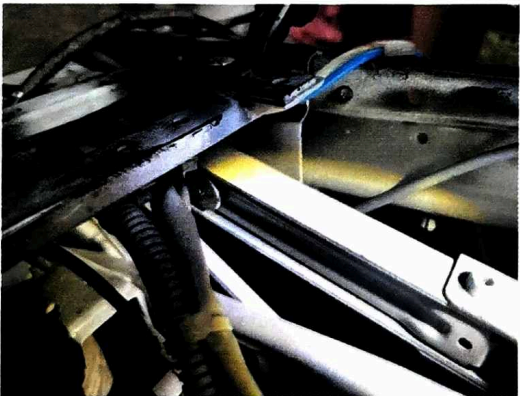
Image 33 Seat Frame Beams

No crack, structure broken, weld off, screw loosen or fall off, or severe deformation detected;

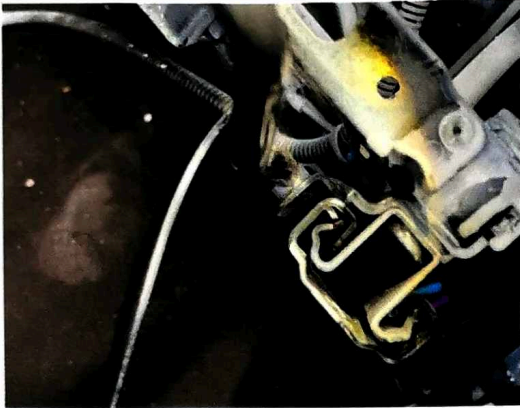
Image 34 Rails

No crack, structure broken, weld off, screw loosen or fall off, or severe deformation detected;  
The sliding rail could be locked, unlocked or adjusted smoothly after whole test mileage.

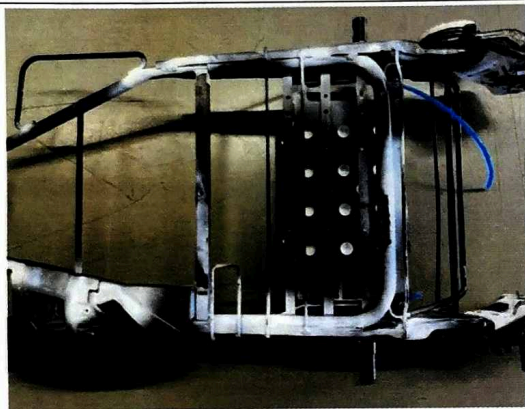
Image 35 Seat Back Frame

No crack, structure broken, weld off, screw loosen or fall off, or severe deformation detected;  
Especially no structure failure of curving and welding position detected.

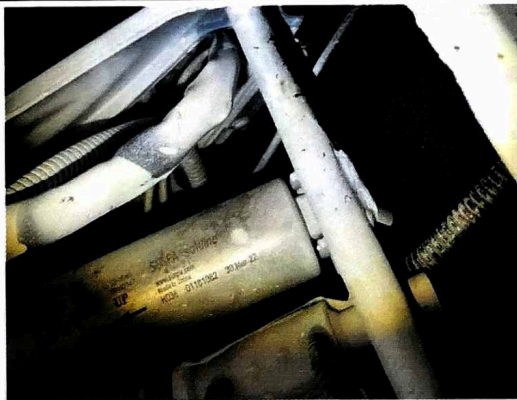
Image 36 Damper and Valve System

No crack, structure broken, weld off, screw loosen or fall off, or severe deformation detected;  
Damper and pneumatic functions are good to use.

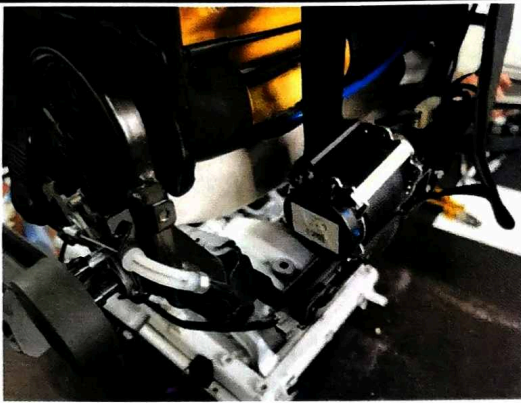
Image 37 Seat Belt

Seat Belt is good to use after whole test mileage;  
No crack, structure broken, weld off, screw loosen or fall off, or severe deformation detected on the new designed retractor position.

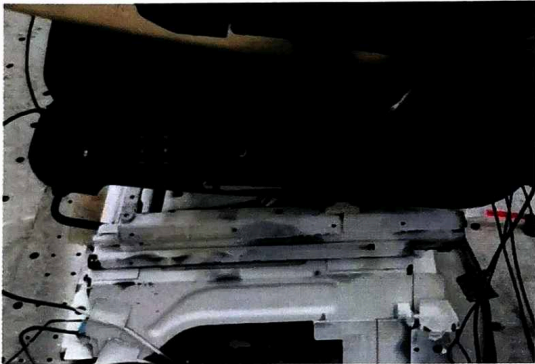
Image 38 Seat Riser

No crack, structure tearing, severe deformation or weld off detected on seat riser.  
The screw connection between rail and seat riser maintained well.

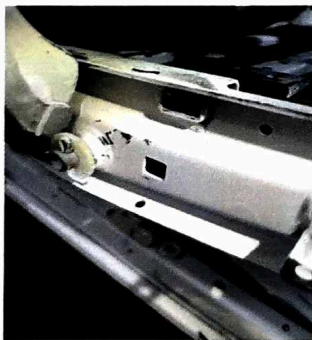
Image 39 PLAN A SHAFT

According to the full running mileage inspection result, the testing target had a good performance on structure strength and function maintaining. No frame structure, appearance or function failure detected. The only failure is The rivet head of Suspension shaft fell off during 92% - 100% due to the abrasion between scissors frame and the head. Space left for movement parts is not enough to guarantee the shaft well working in whole test mileage.

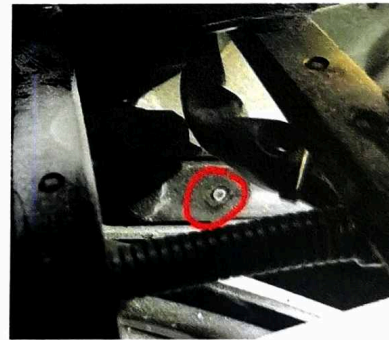
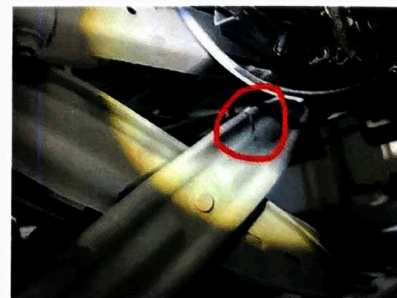
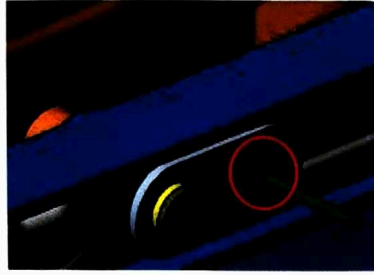
Date	Test-cycles (%)	Test result / remarks / particularities / failures Failures: Pos.Nr. / Part description / Part runtime / Failure description	Picture No.
3-8-22	0	Check OK.	
4-8-22	6	Check OK.	
5-8-22	18	Check OK.	
6-8-22	29	Check OK.	
7-8-22	40	Check OK.	
8-8-22	50	Check OK.	
9-8-22	59	Check OK. Sensor malfunction, test stopped.	
11-8-22	59	Goldrare engineer visit and sample full insection Check OK.	
12-8-22	65	Check OK.	
15-8-22	75	Check OK.	
17-8-22	84	Dummy has small displacement	
18-8-22	92	Check OK.	
19-8-22	100	The rivet head (left side) was abraded-off during 92% to 100% mileage.	See picture 40-42

The rivet head (left side) was abraded-off during 92% to 100%.
