Test Report

Applicant Beijing Goldrare Automobile Parts Co.,LTD.
Address Industrial Park of Liucun Town, Changping District, Beijing, China
Sample Name H6 Driver seat
Quantity 1pcs
Model /
Received 01/07/2022
Testing Period 01/07/2021-11/07/2022
Test Type commission test

3.1. 6-Axis vibration test

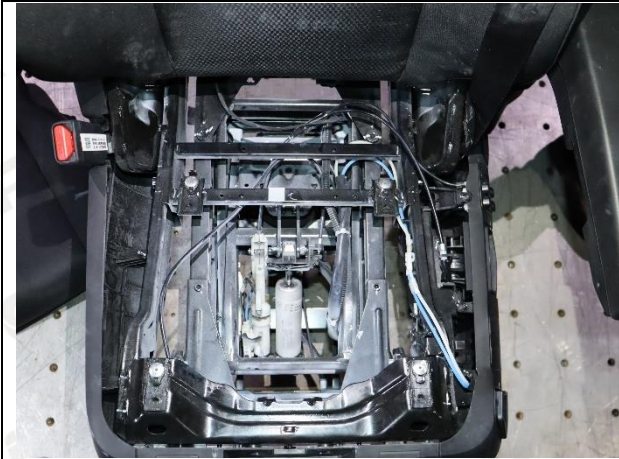
After test-Seat Suspension Frame

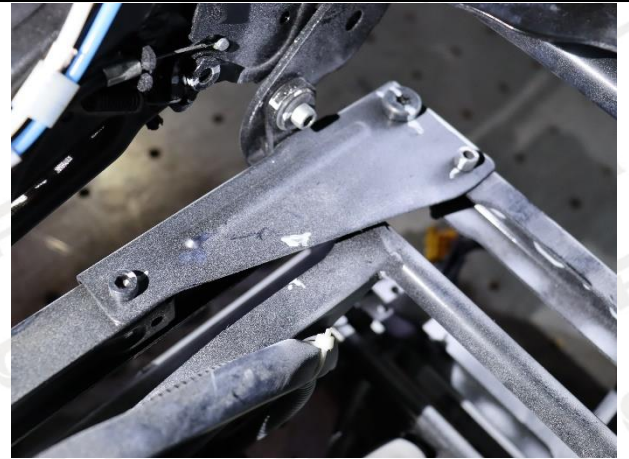
The new designed tilt structure showed a good performance during whole test mileage, no teeth slip occurred and the position could be maintained perfectly.
Sliding Rail	No crack, structure broken, weld off, screw loosen or fall off, or severe deformation detected; The sliding rail could be locked, unlocked or adjusted smoothly after whole test mileage.
Seat Back Frame	No crack, structure broken, weld off, screw loosen or fall off, or severe deformation detected; Especially no structure failure of curving and welding position detected.
Seat Riser	No crack, structure tearing, severe deformation or weld off detected on seat riser. The screw connection between rail and seat riser maintained well.
Dummy's position	A mark on the dummy should be made to record the position change, just use for position correction, no critical evaluation.
Fastener Bolts	The connecting bolts between the seat frame and the shock absorber cannot be loosened The connecting bolts between the bottom bracket and the slide rail cannot be loosened The fastening bolts of the elevation tooth plate cannot be loosened

After test-Tilt System

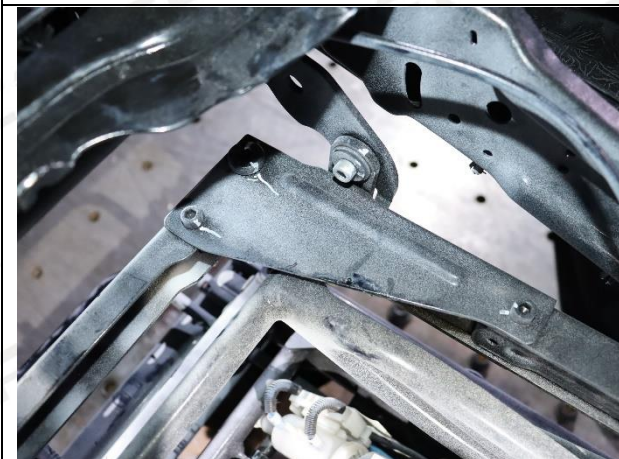
After test-Tilt System

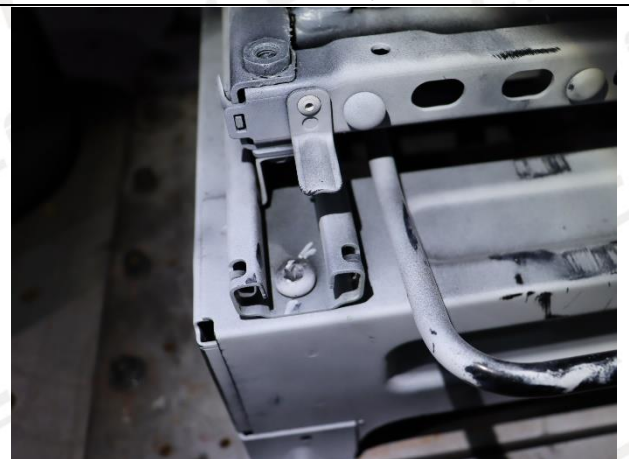
Sliding Rail	No crack, structure broken, weld off, screw loosen or fall off, or severe deformation detected; The sliding rail could be locked, unlocked or adjusted smoothly after whole test mileage.
Seat Back Frame	No crack, structure broken, weld off, screw loosen or fall off, or severe deformation detected; Especially no structure failure of curving and welding position detected.
Seat Riser	No crack, structure tearing, severe deformation or weld off detected on seat riser. The screw connection between rail and seat riser maintained well.
Fastener Bolts	The connecting bolts between the seat frame and the shock absorber are not loose
	The bolts connecting the bottom bracket and the slide rail are not loose
	Elevation gear plate fastening bolts are not loose

After test-Sliding Rail
