Test Report

Applicant Beijing Goldrare Automobile Parts Co.,LTD.
Address Industrial Park of Liucun Town, Changping District, Beijing, China
Sample Name H6 Driver seat
Quantity 1pcs
Model /
Received 27/08/2022
Testing Period 28/08/2021-02/09/2022
Test Type commission test

3.1. 6-Axis vibration test

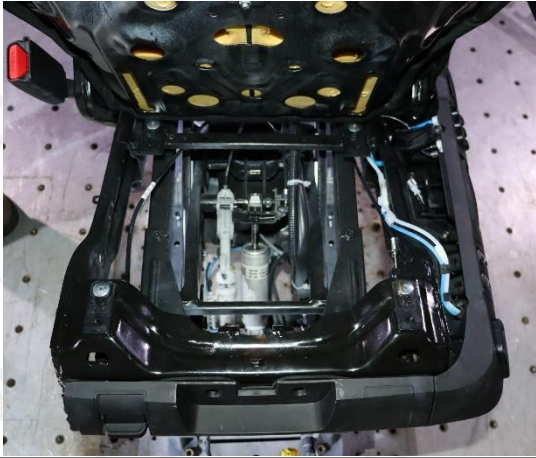
After test-Seat Suspension Frame

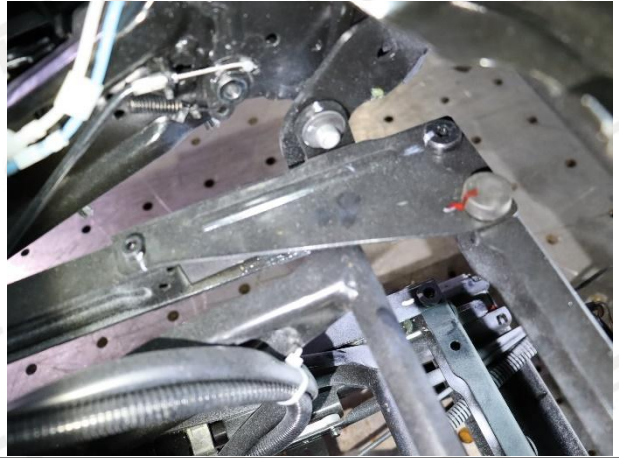
After test-Tilt System

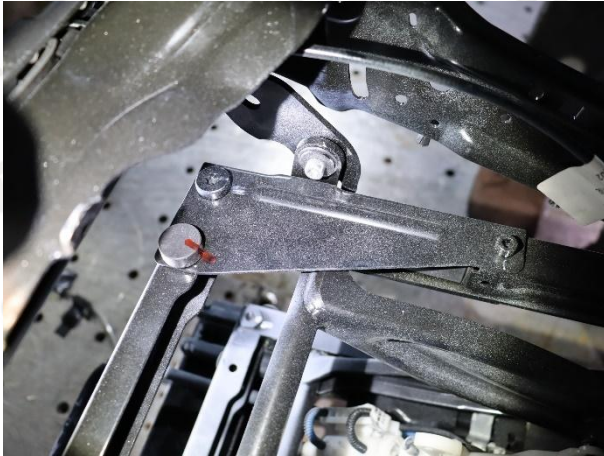
After test-Tilt System

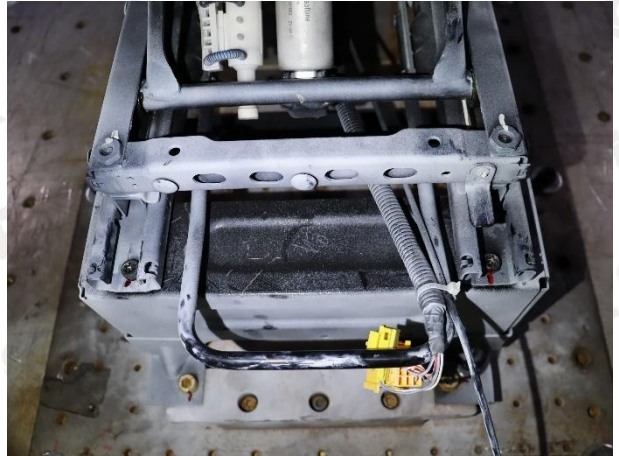
After test-Sliding Rail

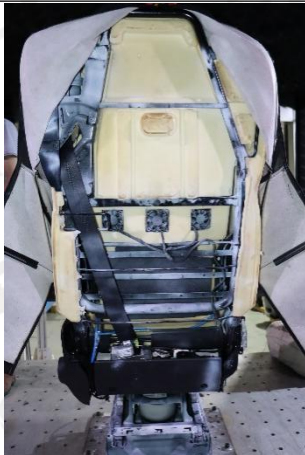
After test-Seat Back Frame

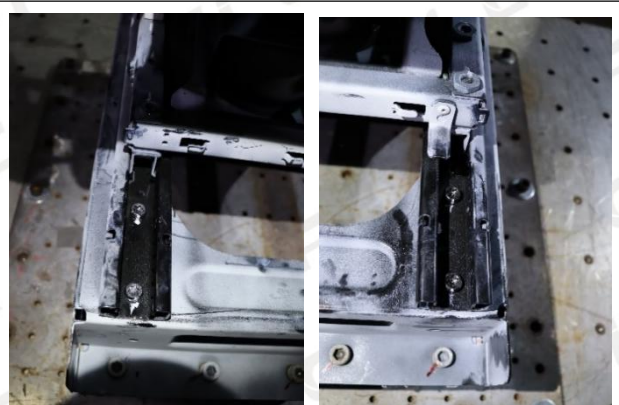
After test-Sliding Rail
