# Test Report

Applicant Beijing Goldrare Automobile Parts Co.,LTD.  
Address Industrial Park of Liucun Town, Changping District, Beijing, China  
Sample Name H6 passenger seat  
Quantity 1pcs  
Model /  
Received 18/06/2021  
Testing Period 23/07/2021-03/08/2021  
Test Type commission test

## 2. Test method

### 3.1. 6-Axis vibration test

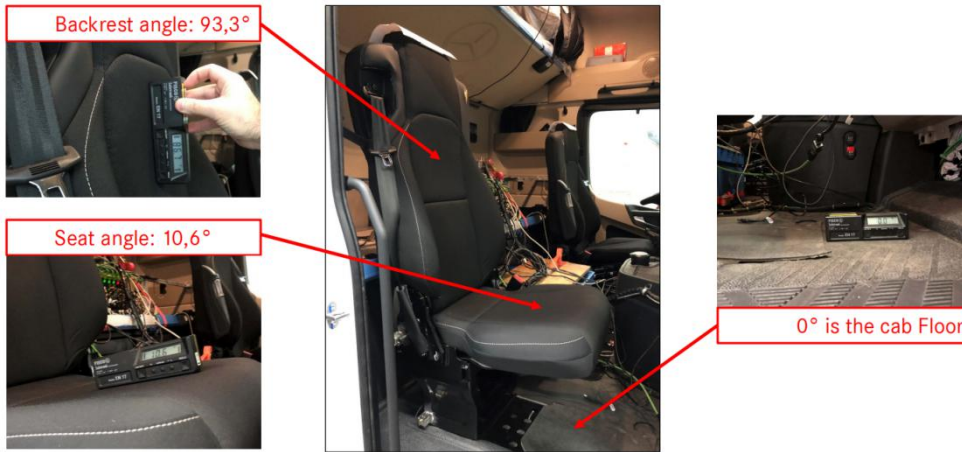
Co-Driver Seat Position:

2.2 Adjust the seat to the design position

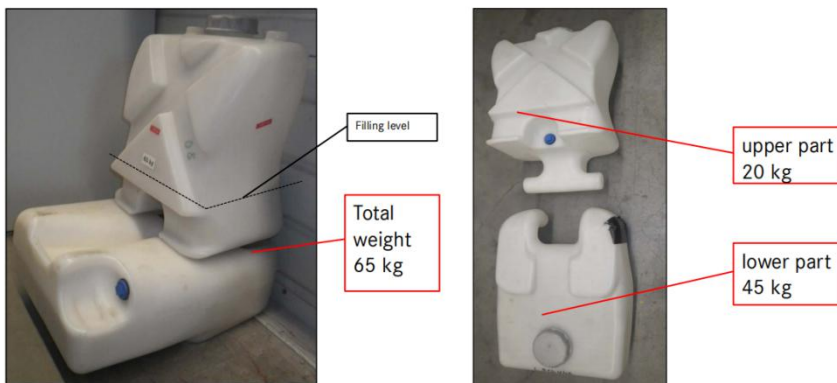
## 2.4 Prepare a test dummy as shown below

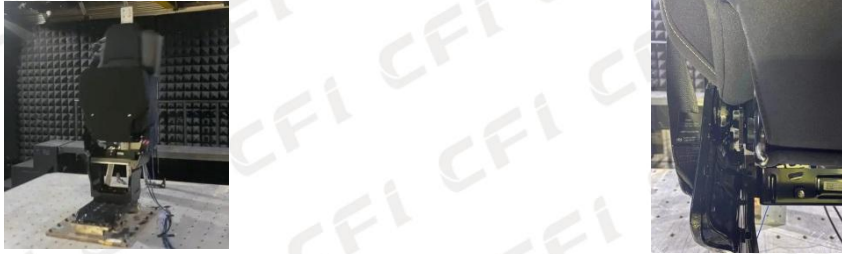
1	
Failure description	The seat shook badly when cushion in folded position w/o dummy and strong squeak noise occurred from seat frame
Test progress	Iteration of the function seat in folded status
Cause of failure	The gap between cushion frame and rotating structure is too large so that abnormal shake and noise generated by hit between the metal plates when the cushion folded.

Failure handling method	Used washers to compensate the opening size of the seat cushion frame, the abnormal shake and noise eliminated

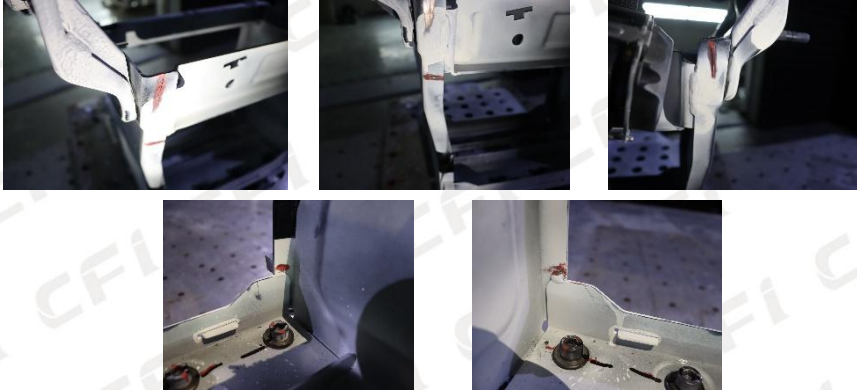
Failure description	Cracks and off-welding on seat base plate

Test progress	100% of the test

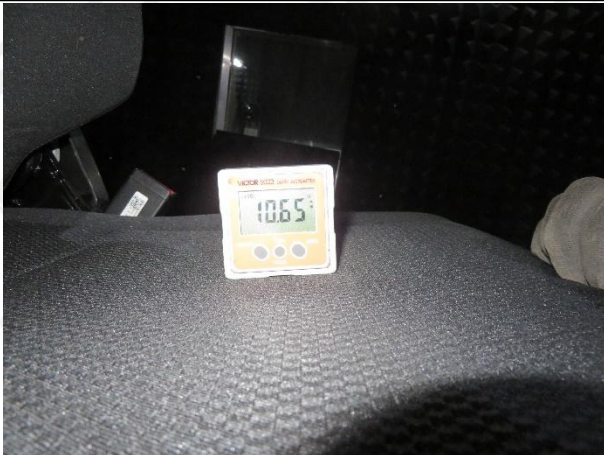
Seat angle

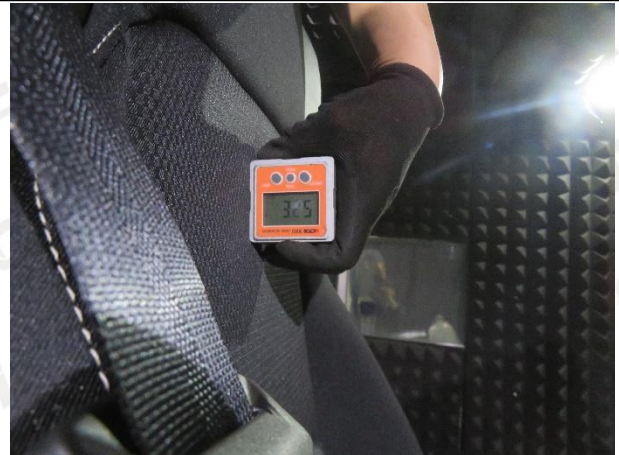
Backrest angle

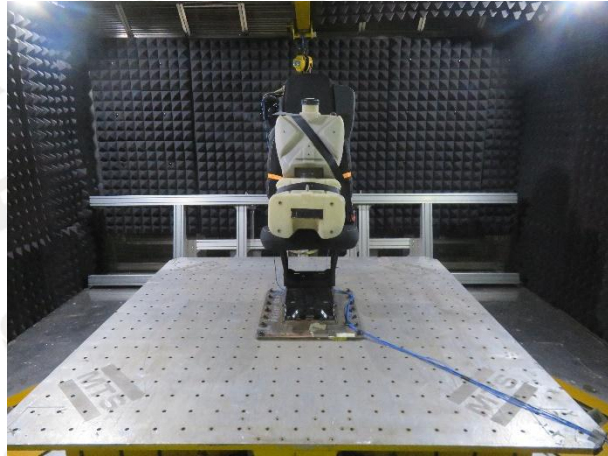
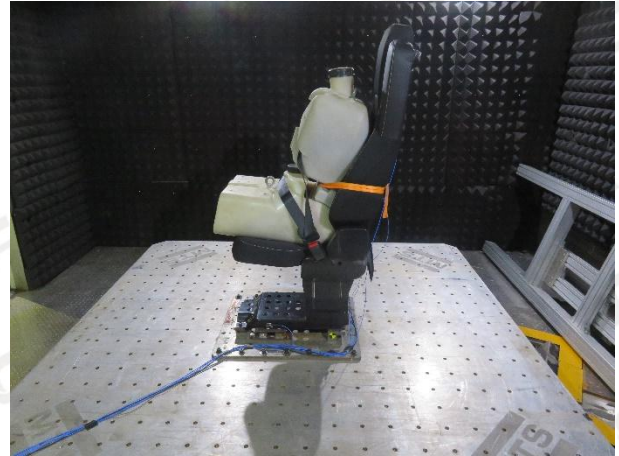
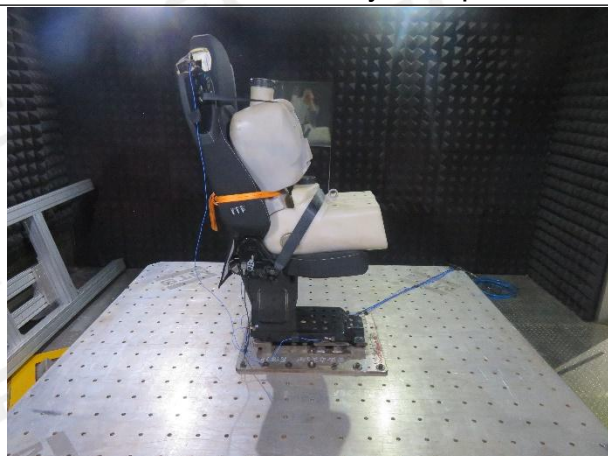
Test with dummy set up

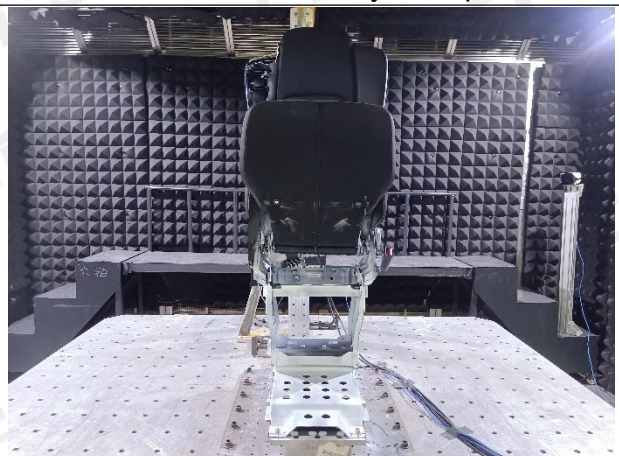
Test without dummy set up
