Test Report

Applicant Beijing Goldrare Automobile Parts Co.,LTD.

Sample Name H6 passenger seat

3.1. 6-Axis vibration test

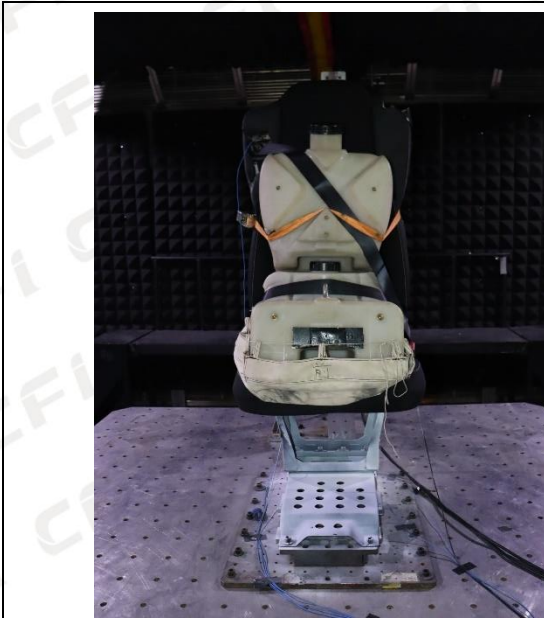
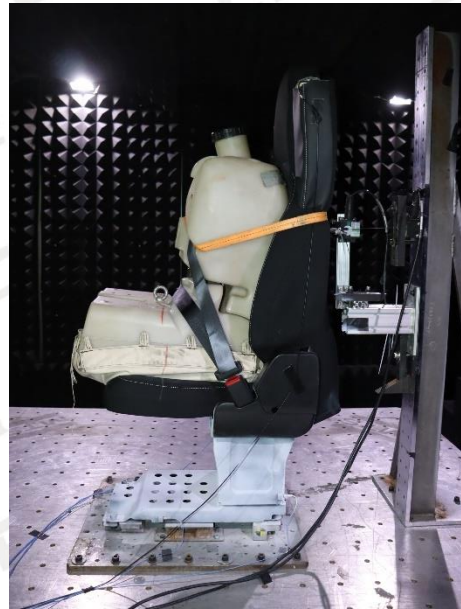
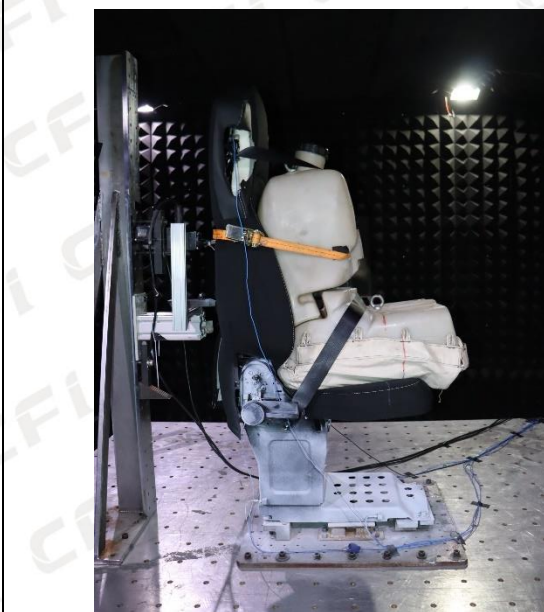
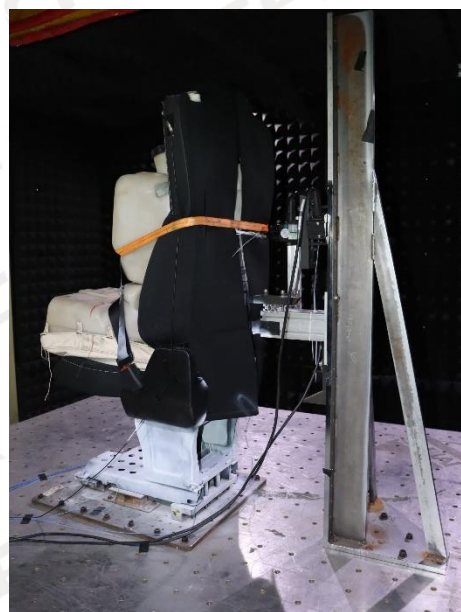
Test with dummy set up

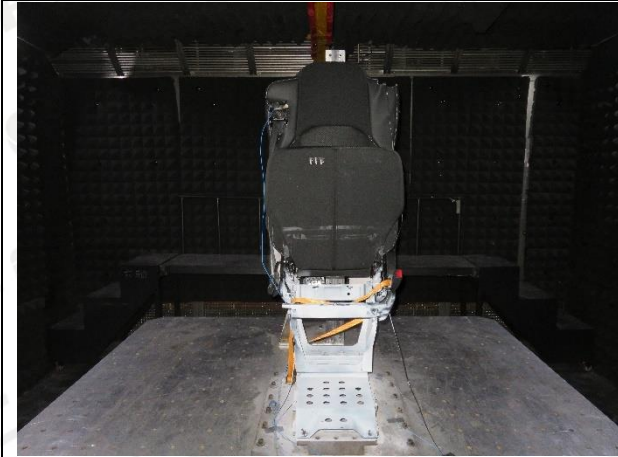
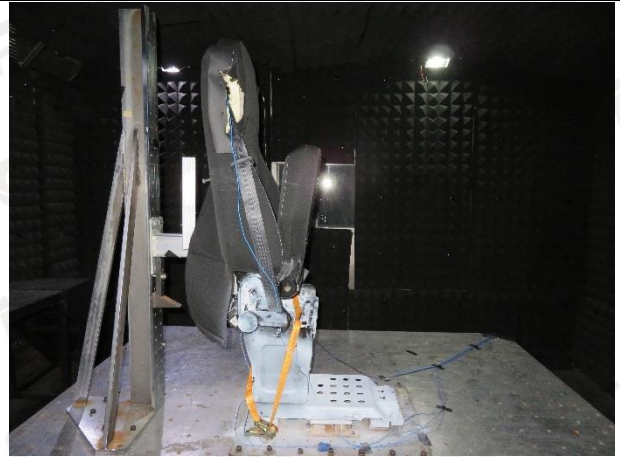
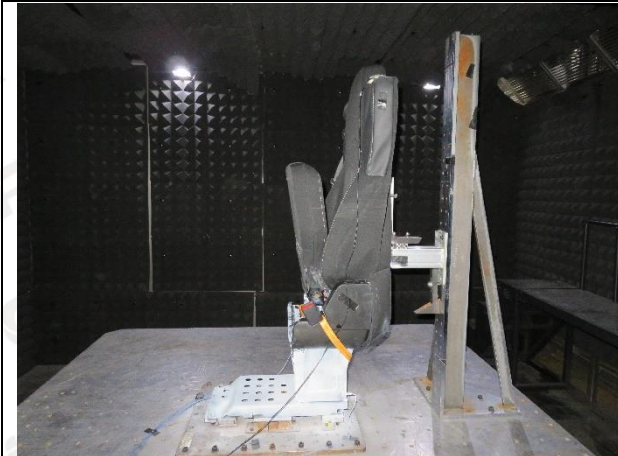
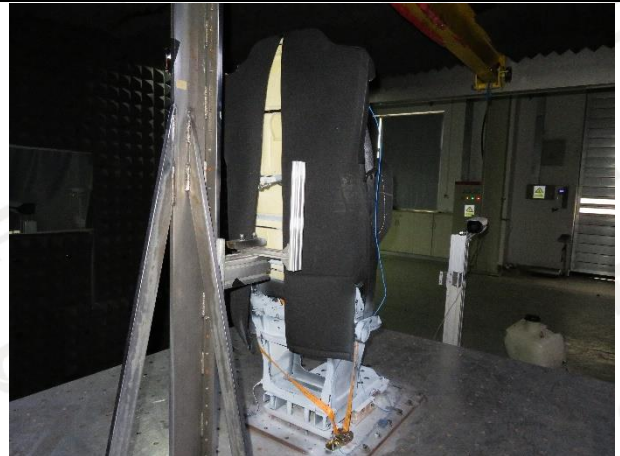
Test without dummy set up

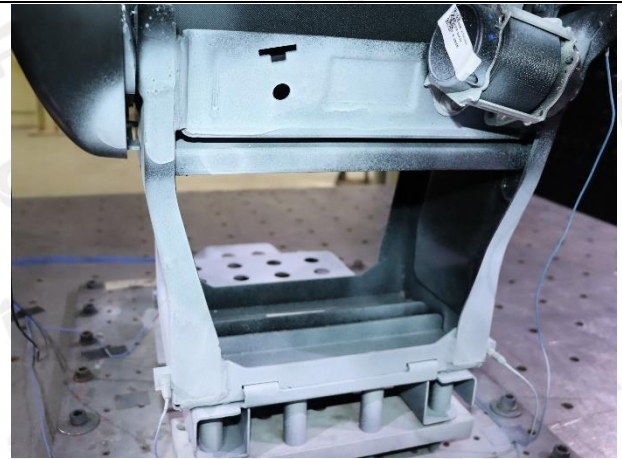
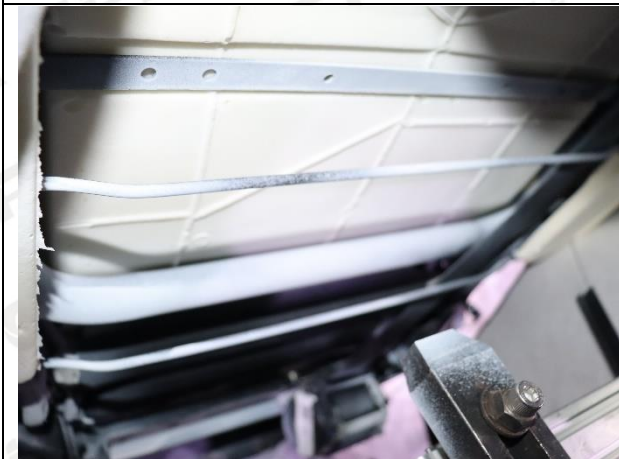
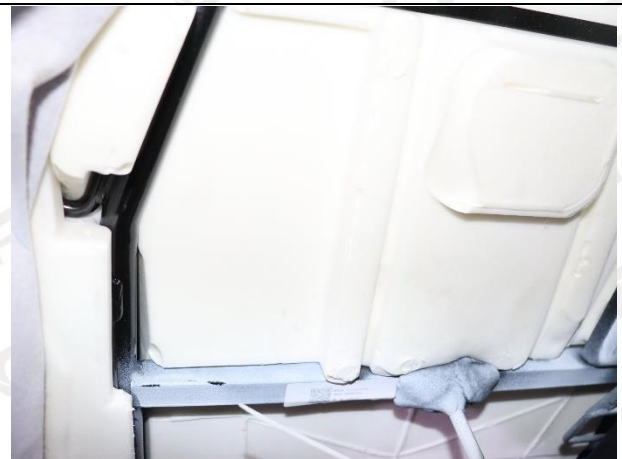
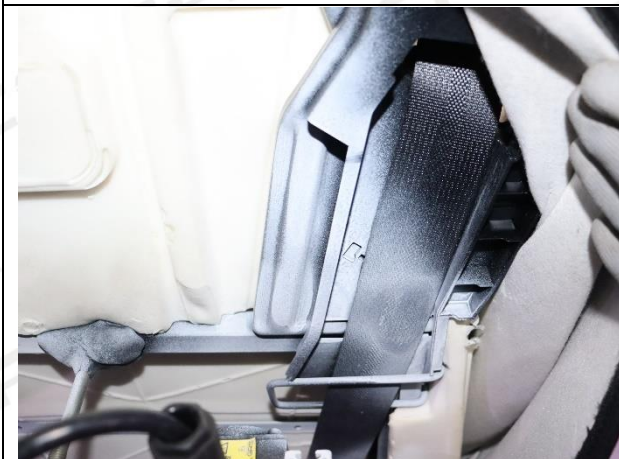
Before test

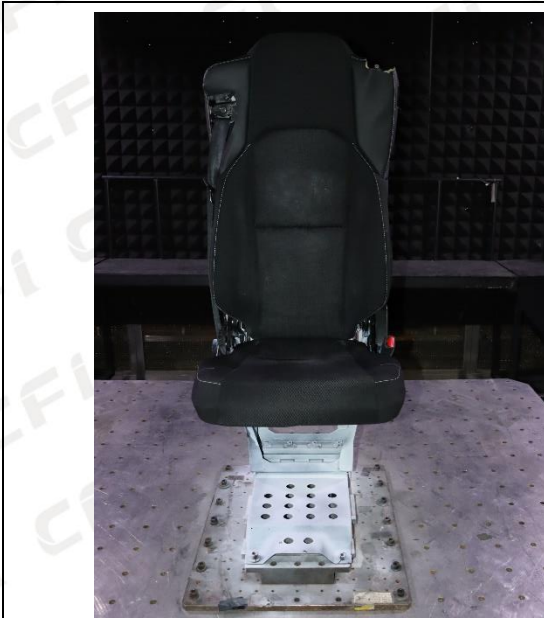
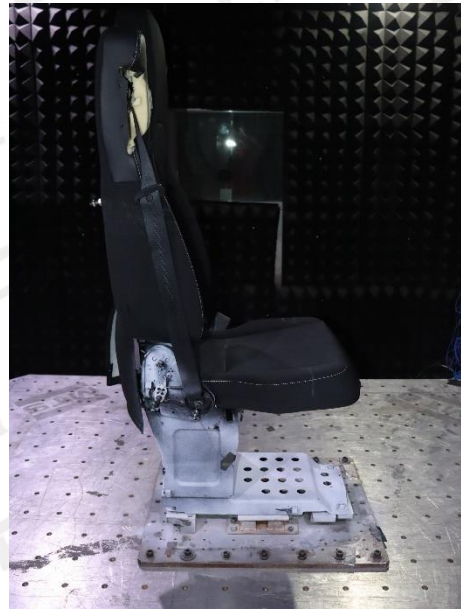
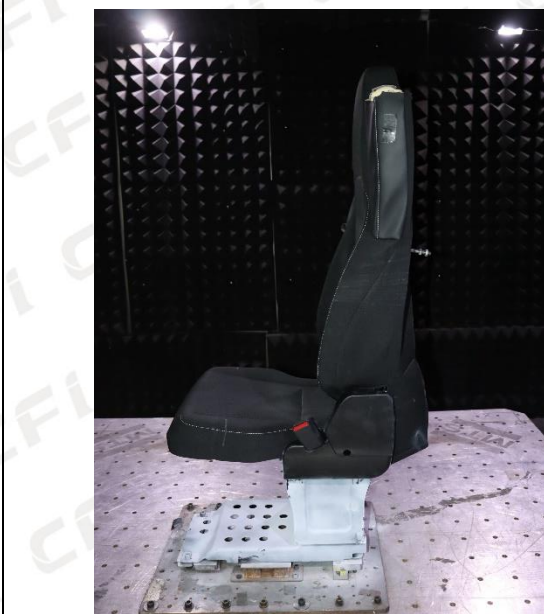
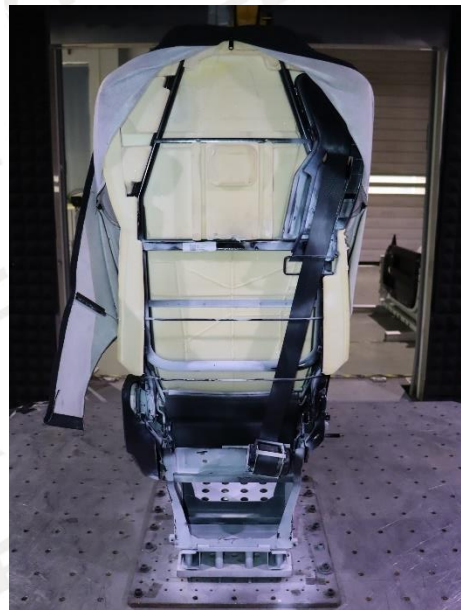
After test

According to the full inspection result, the testing target had a good performance during the whole vibration running mileage and no structure, appearance or function failure detected. The test is judged as **SUCCESSFULLY PASSED**.
