Test Report

Applicant Beijing Goldrare Automobile Parts Co.,LTD.

Sample Name H6 Driver seat

3.1. 6-Axis vibration test

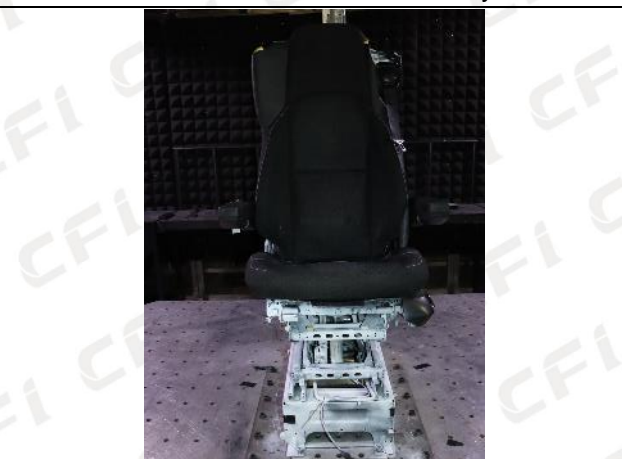
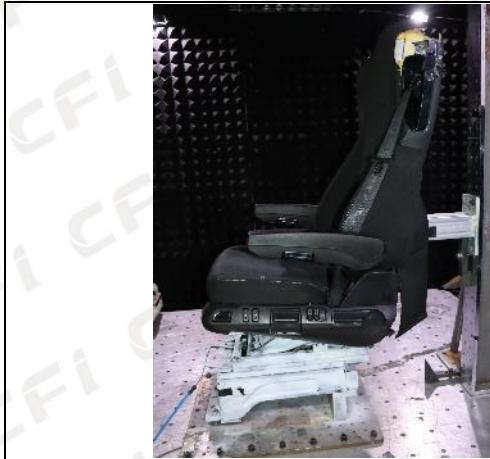
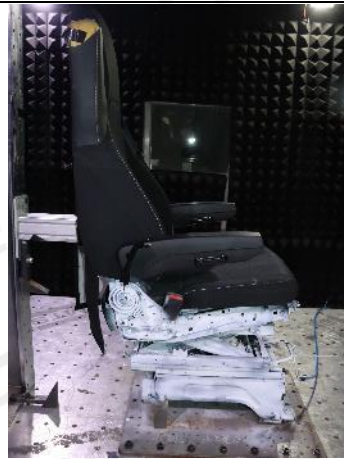
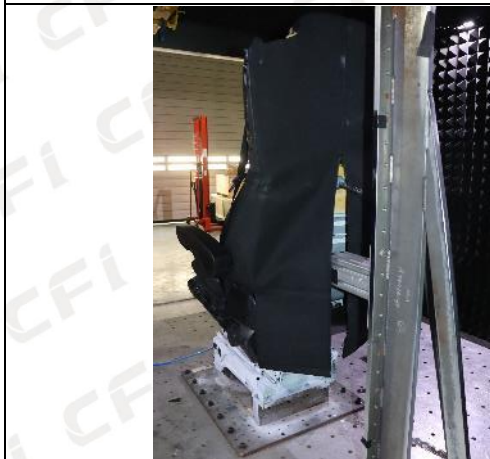
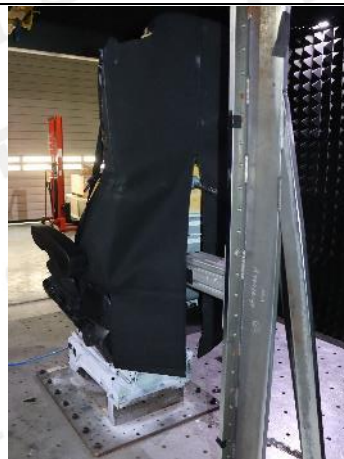
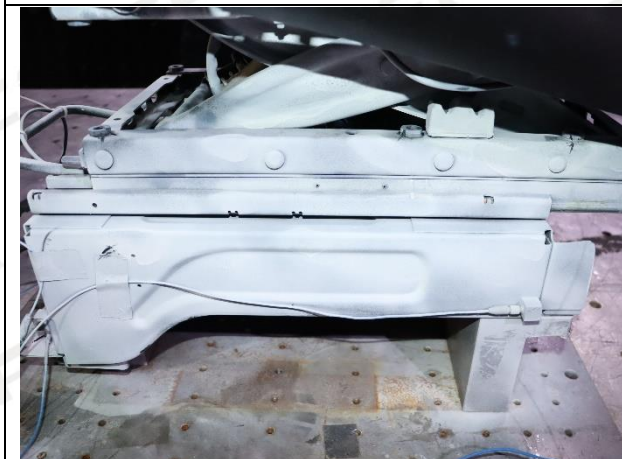
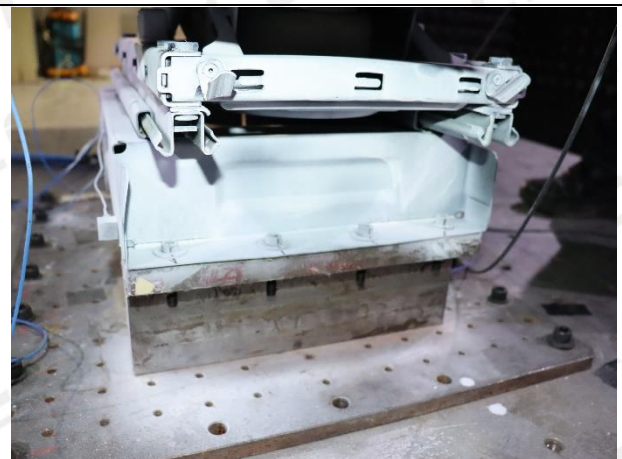
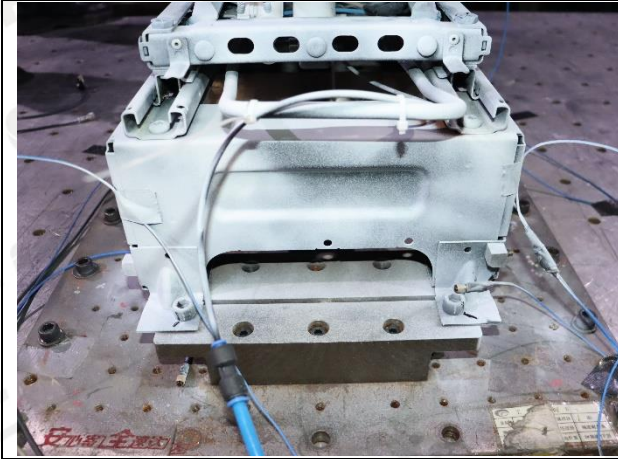
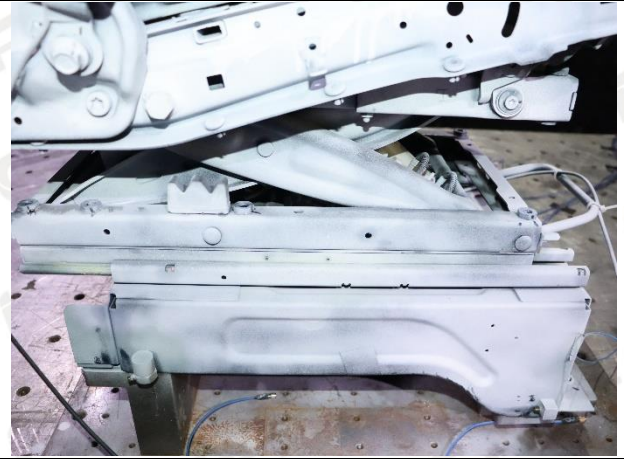
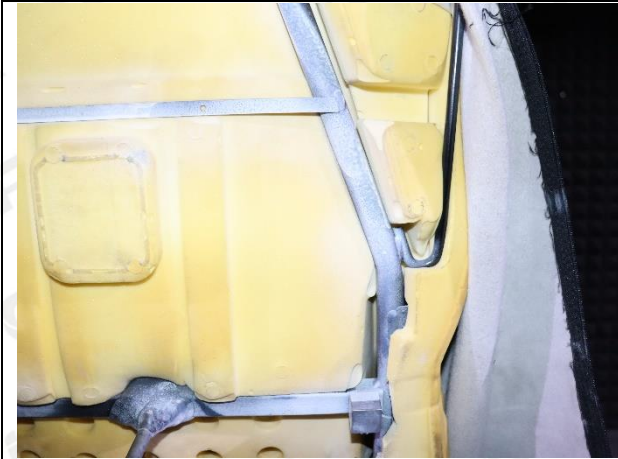
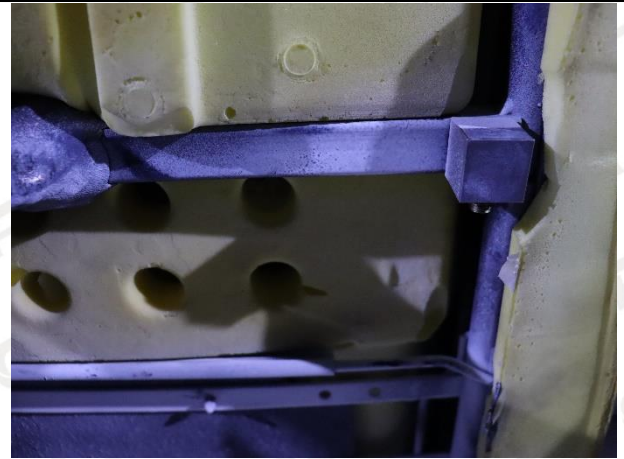
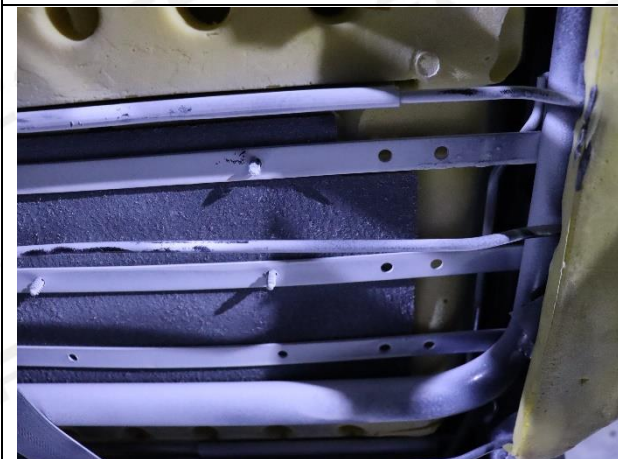
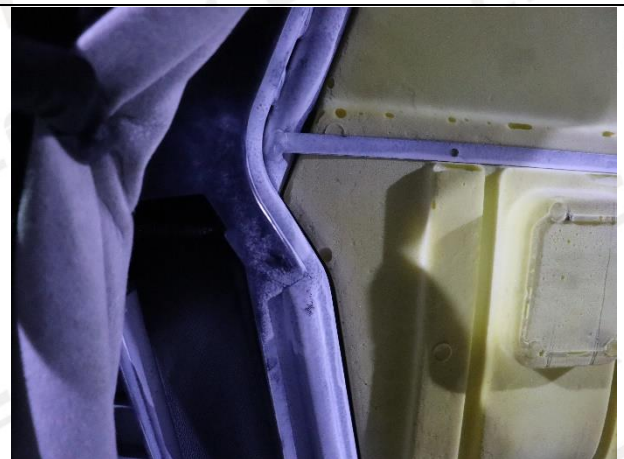
After test

According to the full inspection result, the testing target had a good performance during the whole vibration running mileage and no structure, appearance or function failure detected. The test is judged as **SUCCESSFULLY PASSED**.
