Test Report

Applicant Beijing Goldrare Automobile Parts Co.,LTD.
Address Industrial Park of Liucun Town, Changping District, Beijing, China
Sample Name H6 Driver seat
Quantity 1pcs
Model /
Received 27/08/2022
Testing Period 28/08/2021-02/09/2022
Test Type commission test

3.1. 6-Axis vibration test

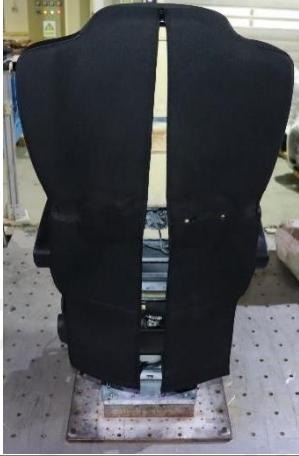
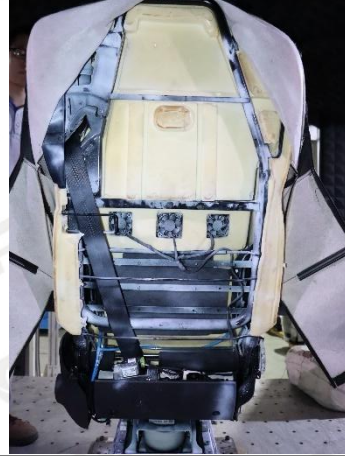
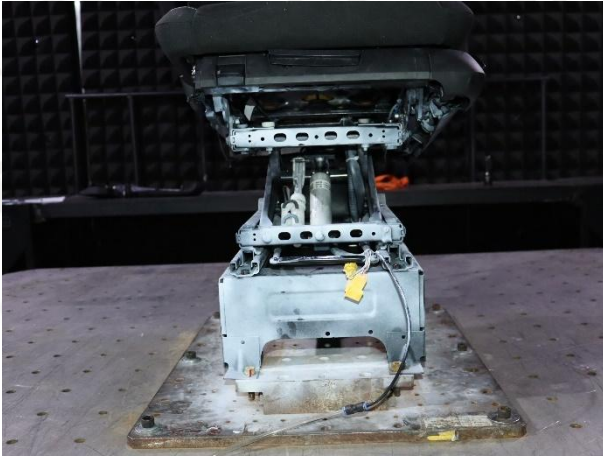
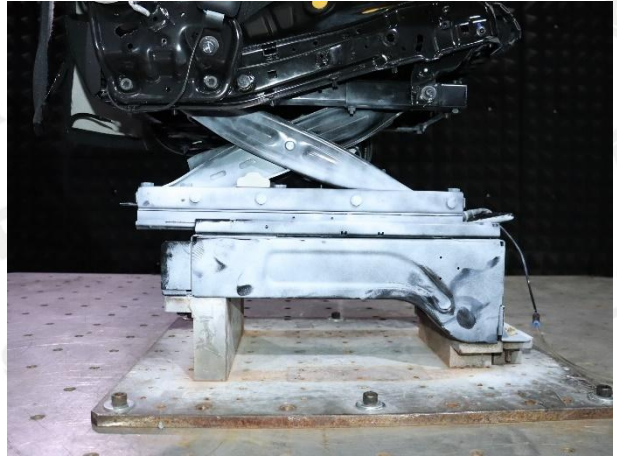
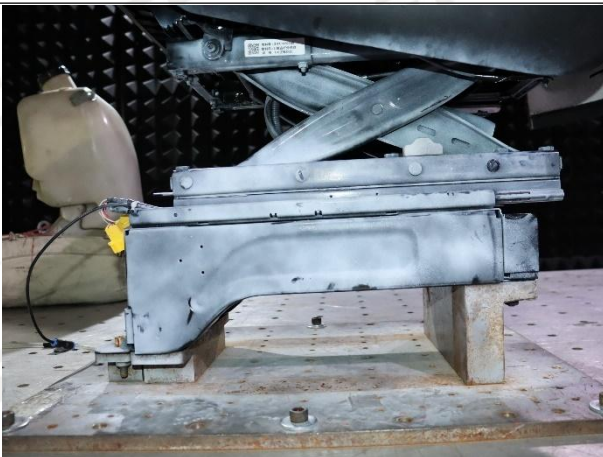
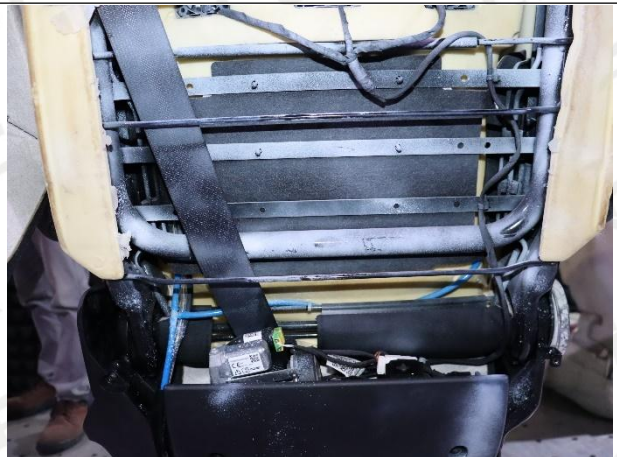
The test runs to 62% and the test stops

62% of test results	
Seat Frame Structure	No crack or off-welding on seat frame
	No weird Sound or Noise
	No deformation on Metal Sheet
	Seat frame right screw loose
Seat Back Adjustment	Unlock smoothly to use, no feeling of abnormal block
	Engaged tooth plate doesn't slipped out by hand disturbing.
	Seat Back Angle adjustment is smooth, no feeling of abnormal block
Suspension	Frame Situation-no crack
	No Abnormal Sound
	Airbag Appearance Situation-no abrasion damage
	Air Path Situation-no leakage or abrasion damage
	Height Adjustment and Fast Lowering function normal
	Sheet Metal Deformation-no Serious Deformation
	Internal-Roller of suspension scissors-bracket Situation-working Smoothly
	Damper Lever Oil Leakage-no Oil Leakage

After test
